NBSIR 75-725 (R)

# Report No. 8

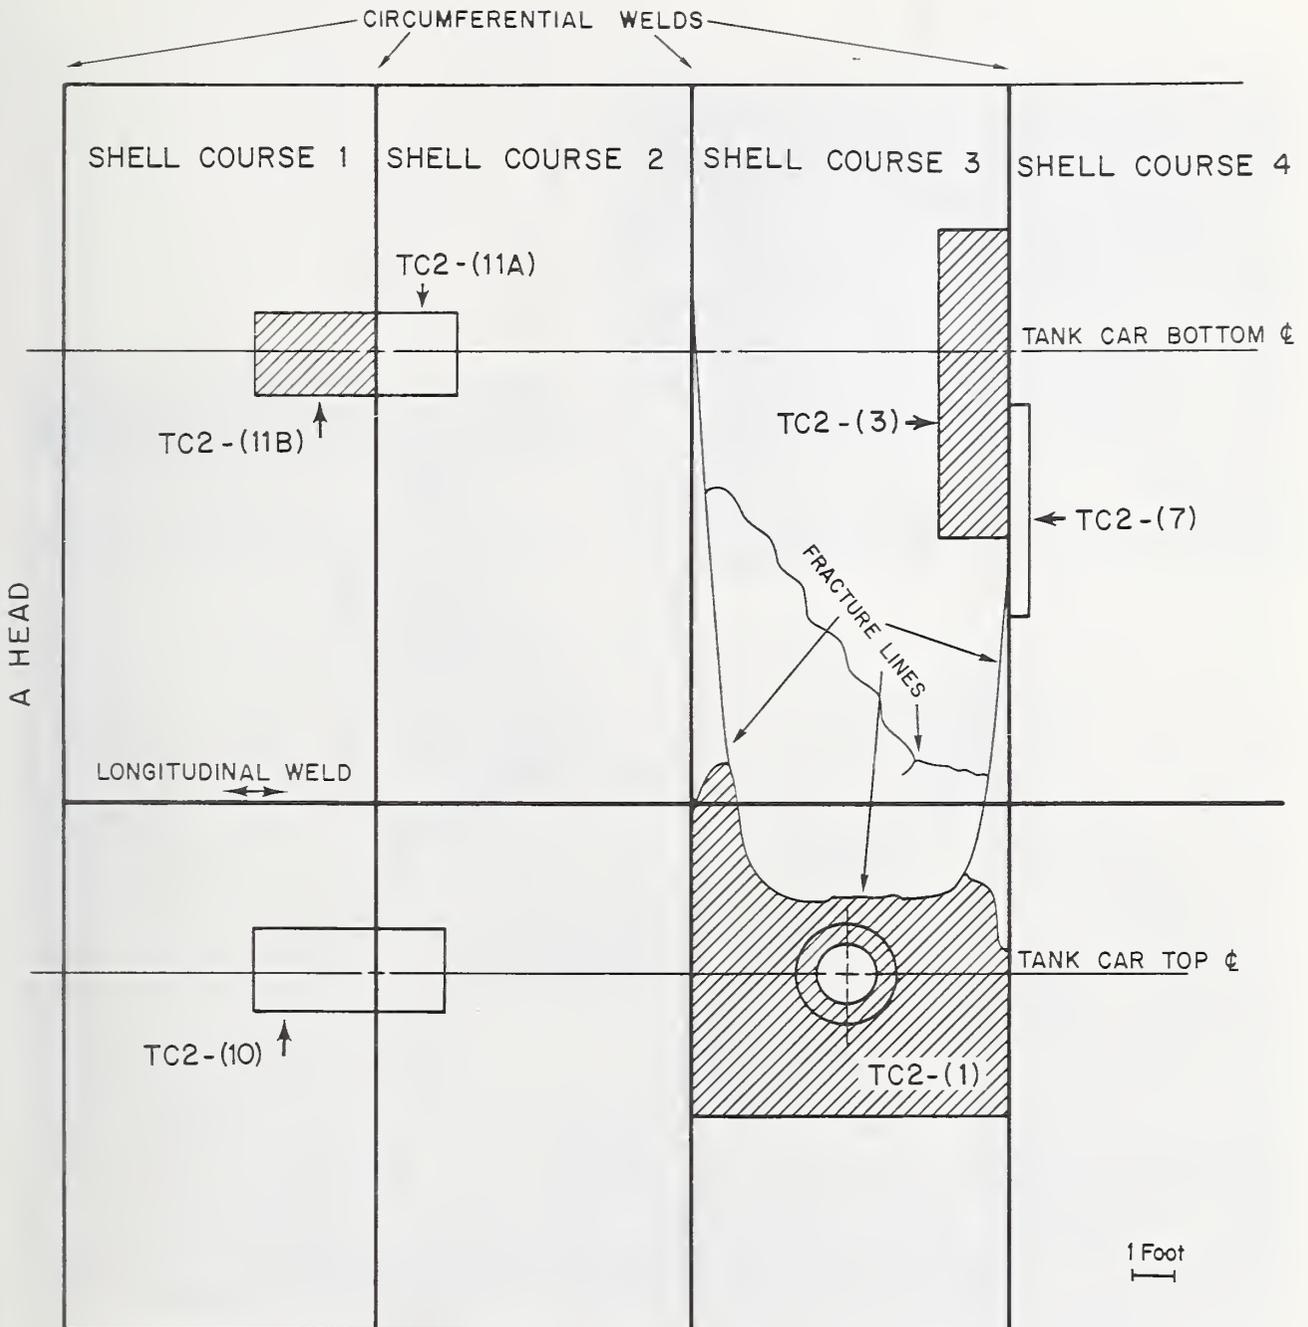
Figure 1. Schematic Diagram Showing the location of NBS Samples in Tank Car RAX 202 as Viewed from the Outside of the Tank Car.

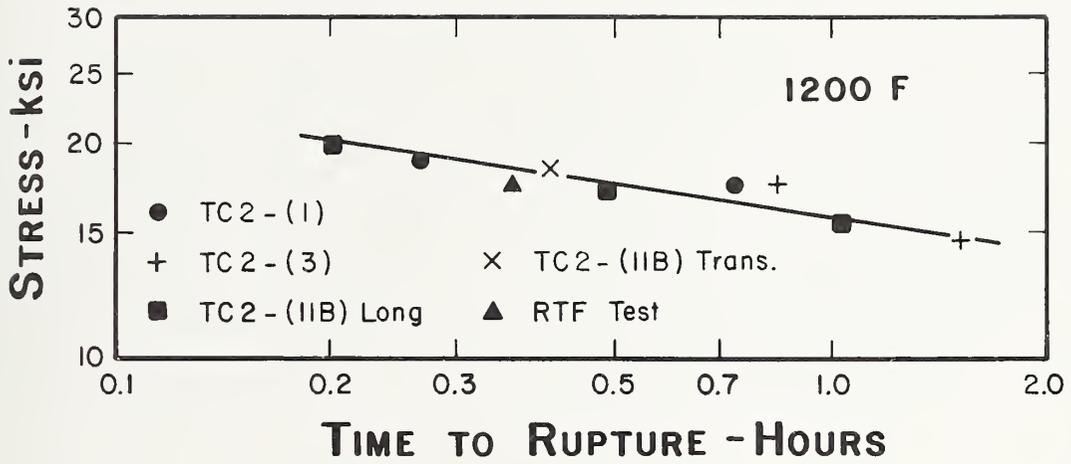
- a. Test Temperature = 1100 F
- b. Test Temperature = 1150 F

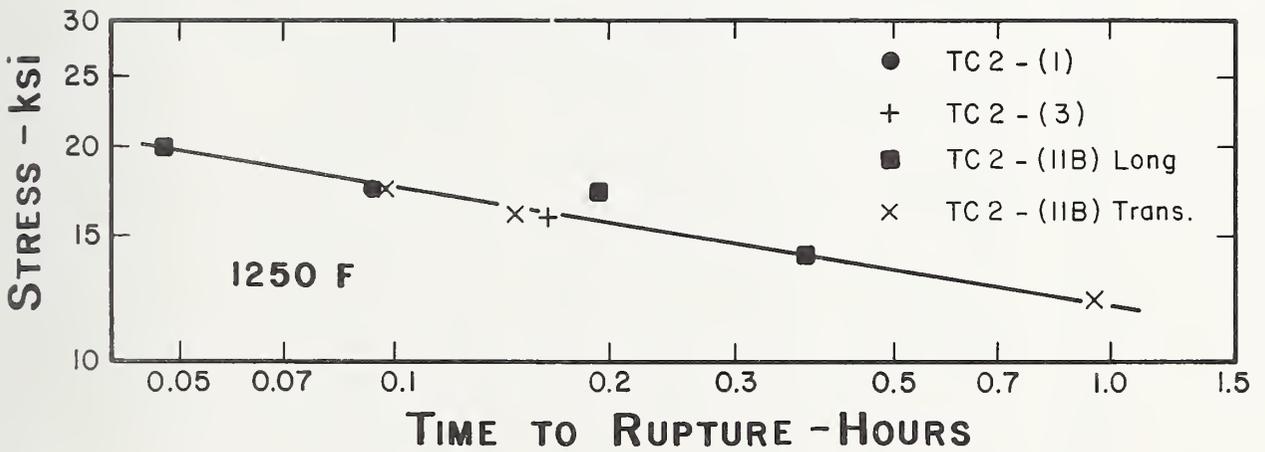
Figure 11. Stress-Ruptures Data for Three Plate Samples from Tank Car RAX 202, AAR M128-B Steel.

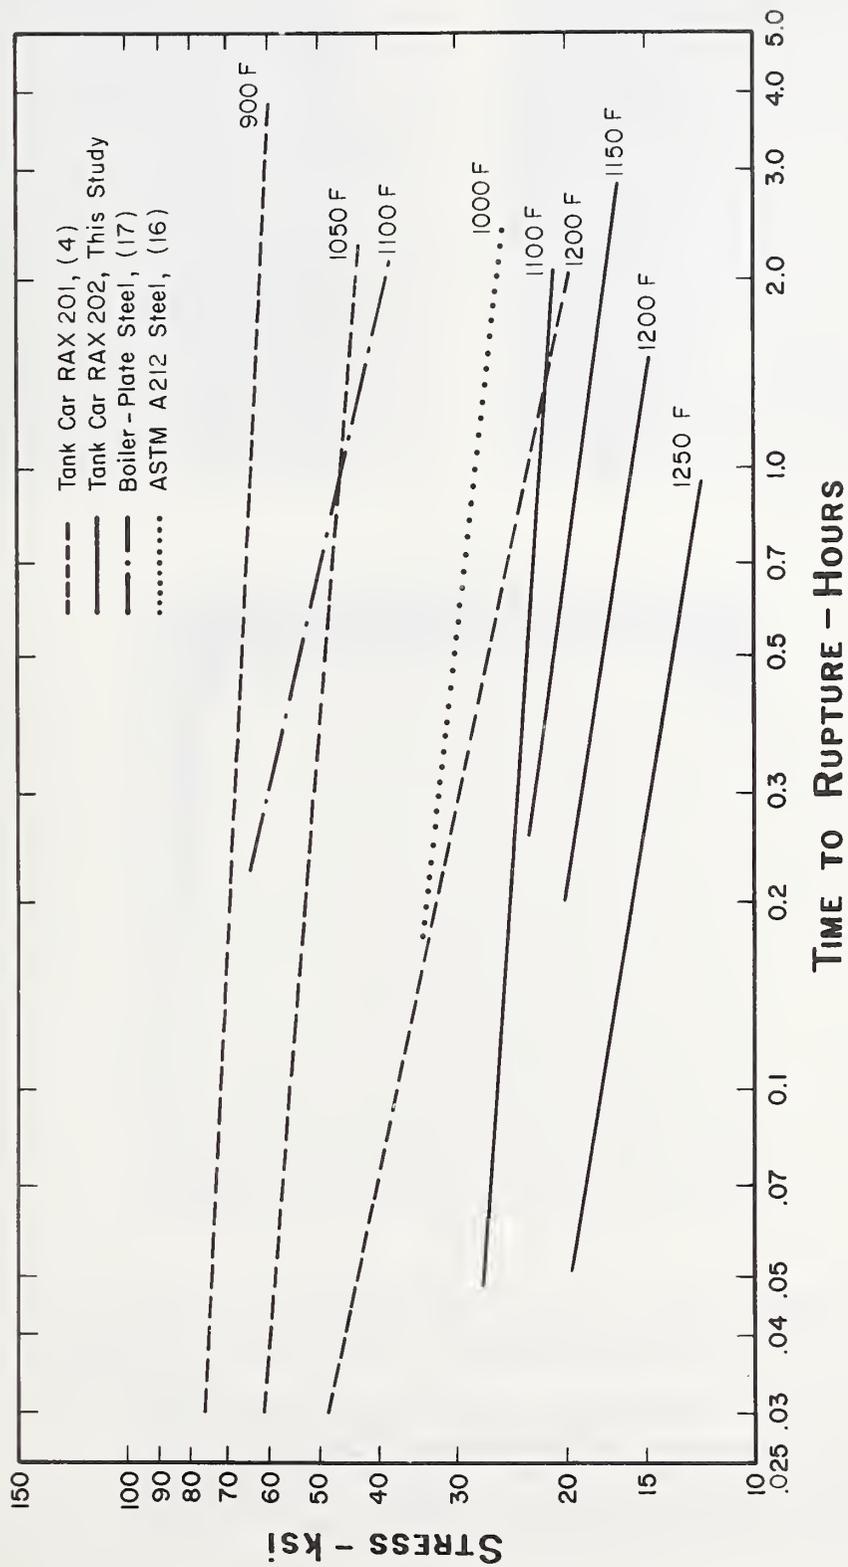
Figure 12. Stress-Rupture Data of Several Pressure Vessel Steels.

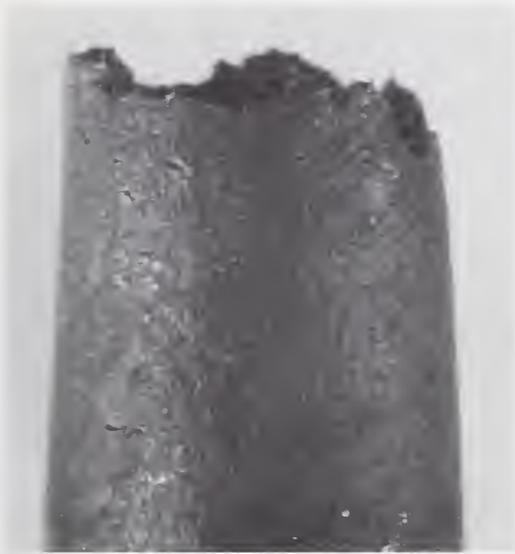
Figure 13. Hot Tension Test Specimen No. 21, Plate Sample TC2-(11B).  
Tested at 1100 F at a crosshead speed of 0.005/0.05 inches per minute.  
a. Photograph of exterior of specimen surface at the fracture surface. Mag. X 15  
b. SEM photograph of exterior of specimen surface at the fracture surface. Mag. X 18  
c. Photograph of fracture profile section, arrows indicate some of the secondary surface cracks. Mag. X 20

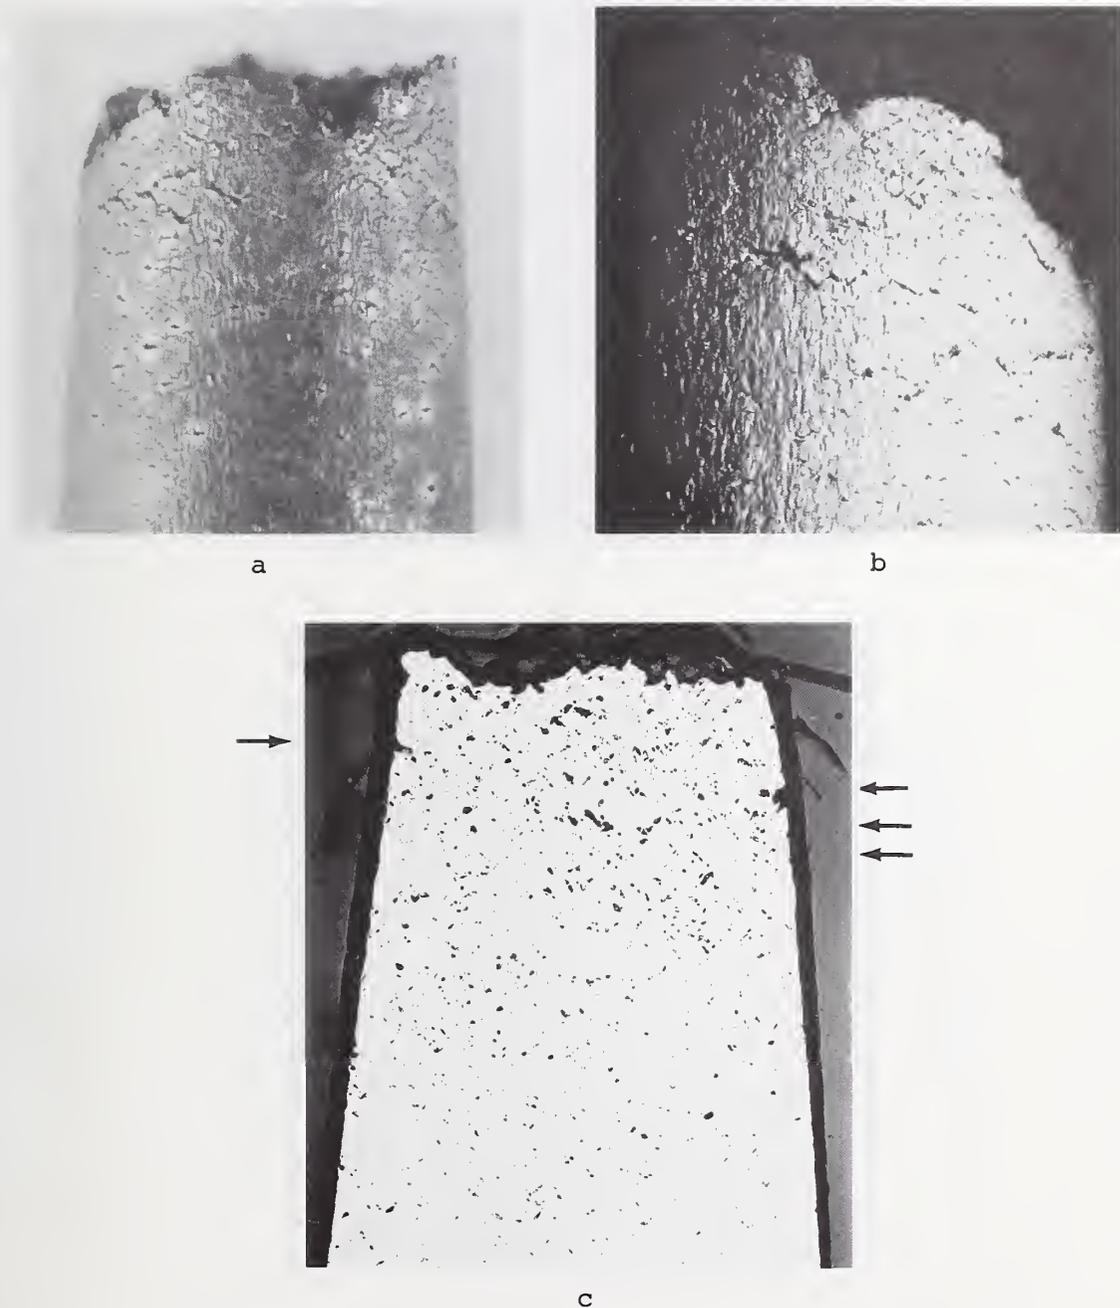
Figure 15. RTF Stress-Rupture Specimen No. 25, Plate Sample TC2-(11B).  
 Tested at 1200 F, initial stress = 19.5 ksi, time-to-rupture = 0.19/0.23 hours.  
 a. Photograph of exterior of specimen surface at the fracture surface. Mag. X 15  
 b. SEM photograph of exterior of specimen surface at the fracture surface. Mag. X 17  
 c. Photograph of fracture profile section, arrows indicate some of the secondary surface cracks. Mag. X 20

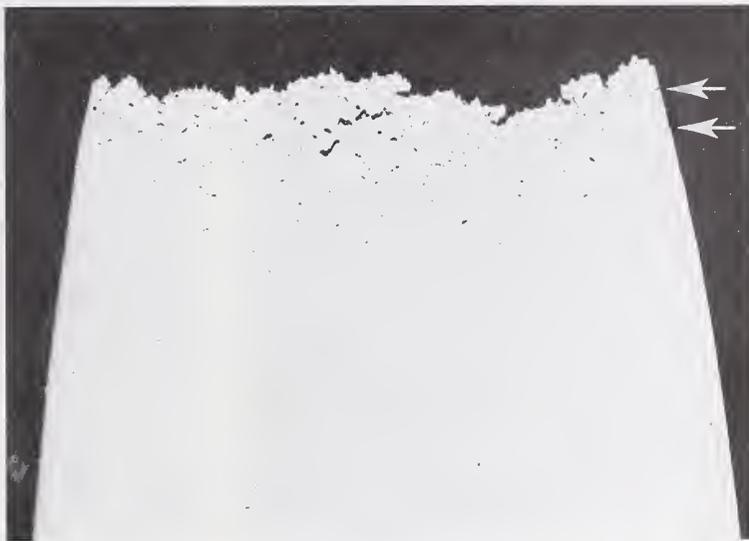
Figure 16. RTF Stress-Rupture Specimen No. 32, Plate Sample TC2-(11B).  
Tested at 1200 F, initial stress = 17.5 ksi, time-to-rupture = 0.36 hours.  
a. Photograph of exterior of specimen surface at the fracture surface. Mag. X 15  
b. Photograph of fracture profile section, arrows indicate some of the secondary surface cracks. Mag. X 20

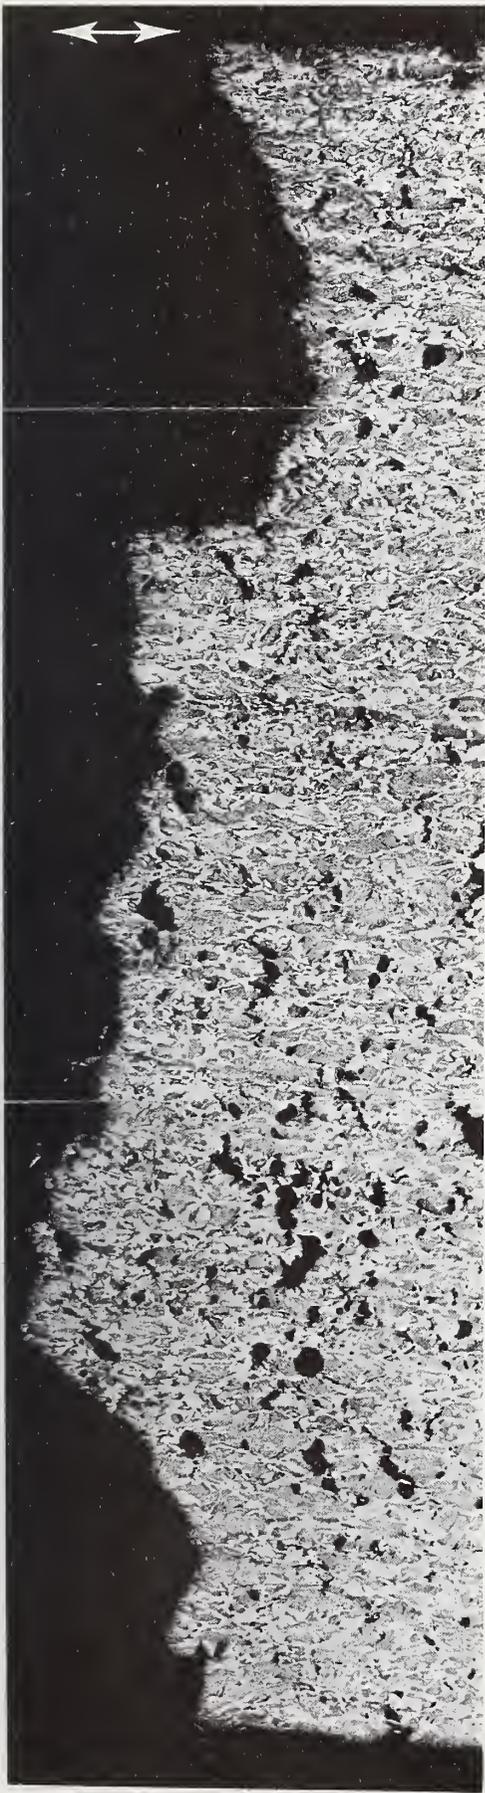
- a. Specimen No. 42, plate sample TC2-(11B), tested at 1150F, initial stress = 22.5 ksi, time-to-rupture = 0.26 hours. Mag. X 20
- b. Specimen No. 6, plate sample TC2-(1), tested at 1200 F, initial stress = 18.9 ksi, time-to-rupture = 0.27 hours. Mag. X 20

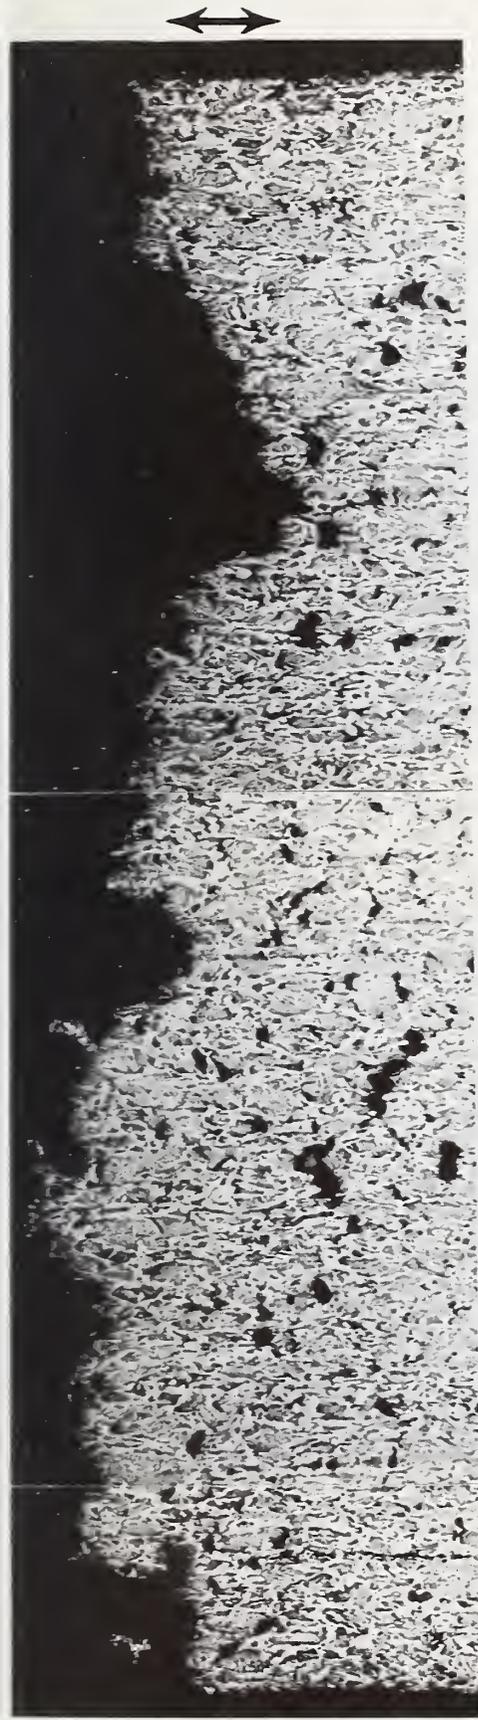
Note the numerous voids beneath the fracture surfaces.

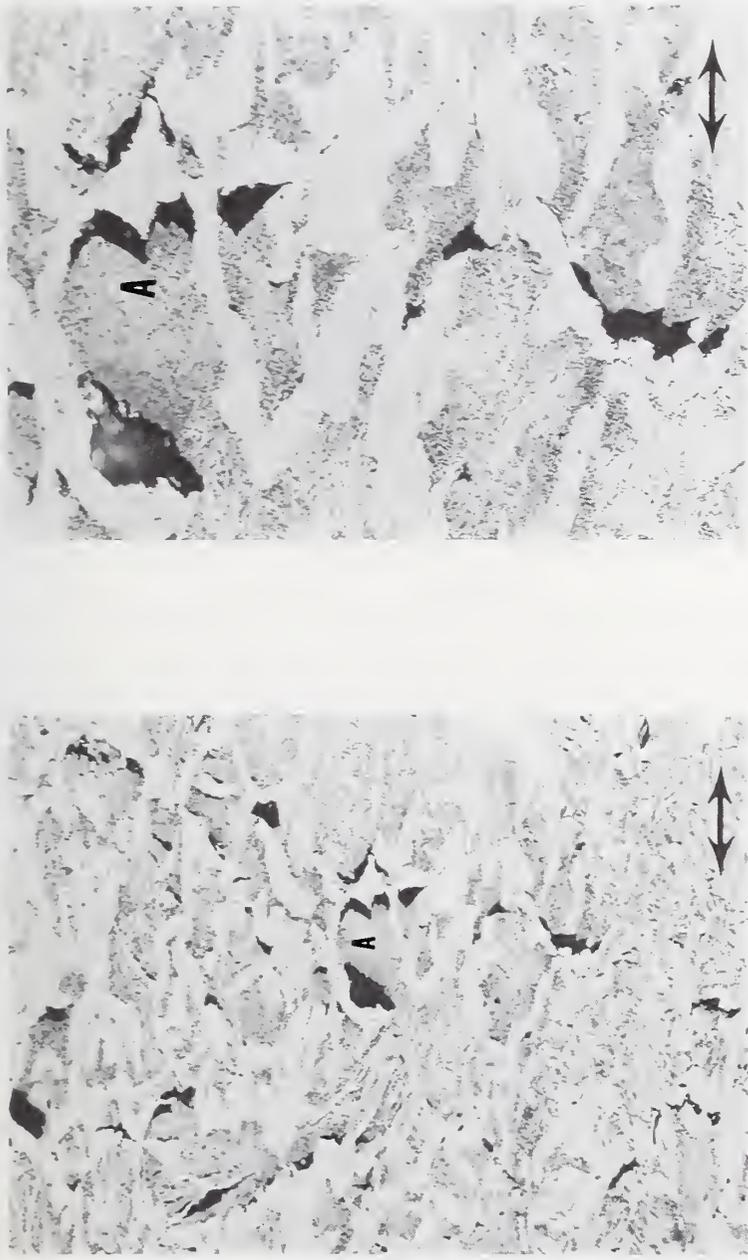
Figure 20. Photomicrographs of the Region Immediately Behind the Fracture Surface. Hot tension test specimen No. 38, plate sample TC2-(11B). The region, marked A, shows cavities forming as a result of the separation of proeutectoid grains from regions of pearlite.

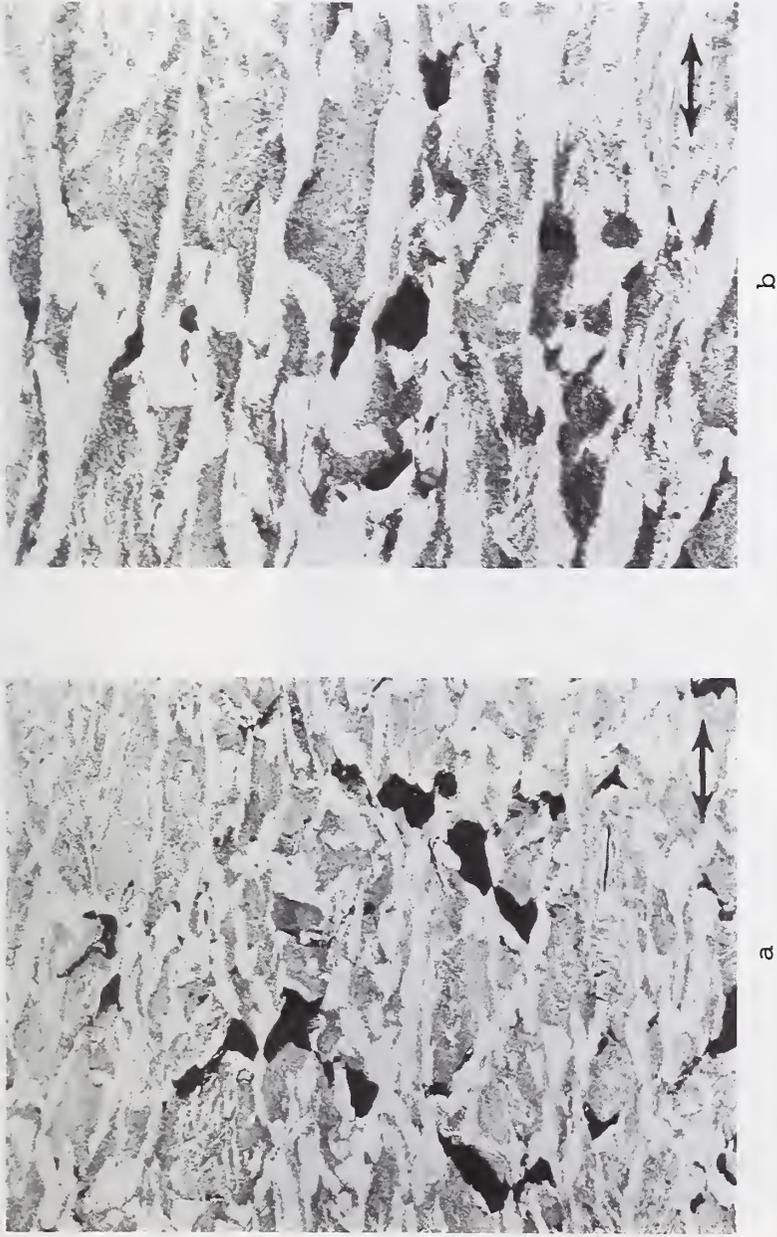
Figure 22. Photomicrographs of the Region Immediately Behind the Fracture Surface.

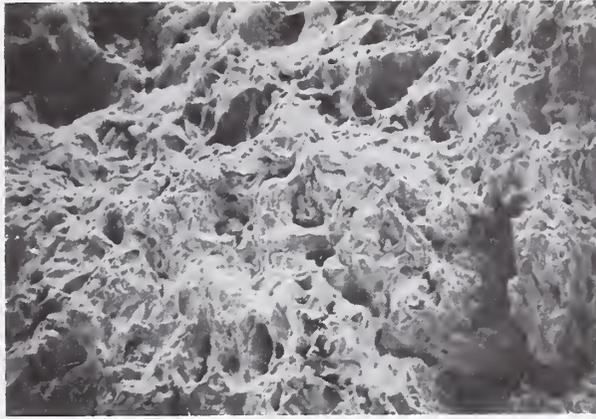
Arrows indicate direction of applied stress, as in a., or the hoop-stress direction, as in b. Etch: 4% Picral

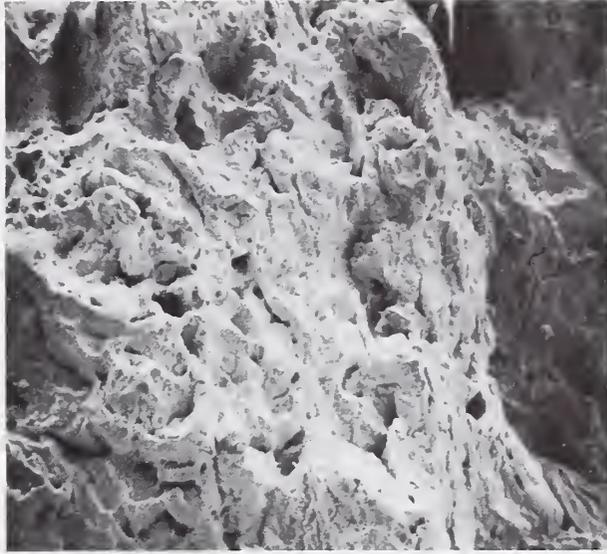
- a. Hot tension test specimen No. 21, test temperature = 1100 F. Mag. X 200
- b. RTF stress-rupture specimen No. 25, test temperature = 1200 F. Mag. X 170
- c. IRH stress-rupture specimen No. 33, test temperature = 1200 F. Mag. X 180

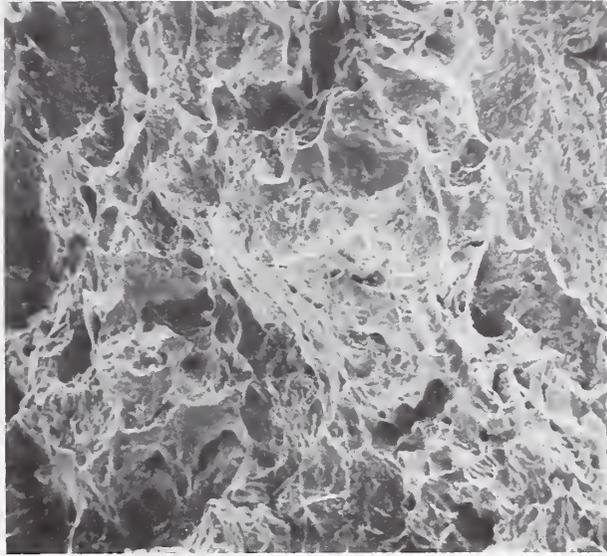
- a. Hot tension test specimen No. 27, test temperature = 1150 F. Mag. X 470
- b. RTF stress-rupture specimen No. 32, test temperature = 1200 F. Mag. X 430
